DAMAGE ASSESSMENT FORM

Building Name KROME RESIDENCE

Address 17845 S.W. 296 STREET

City (or Vicinity) and County DADE COUNTY. MIAMI, FL

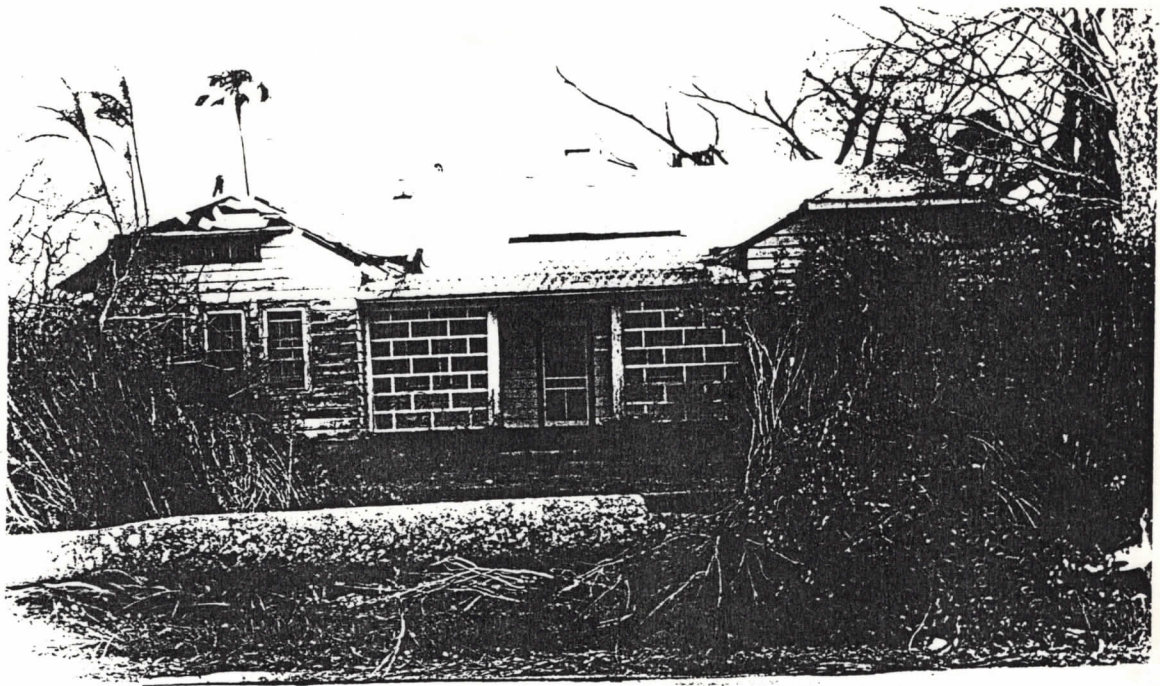
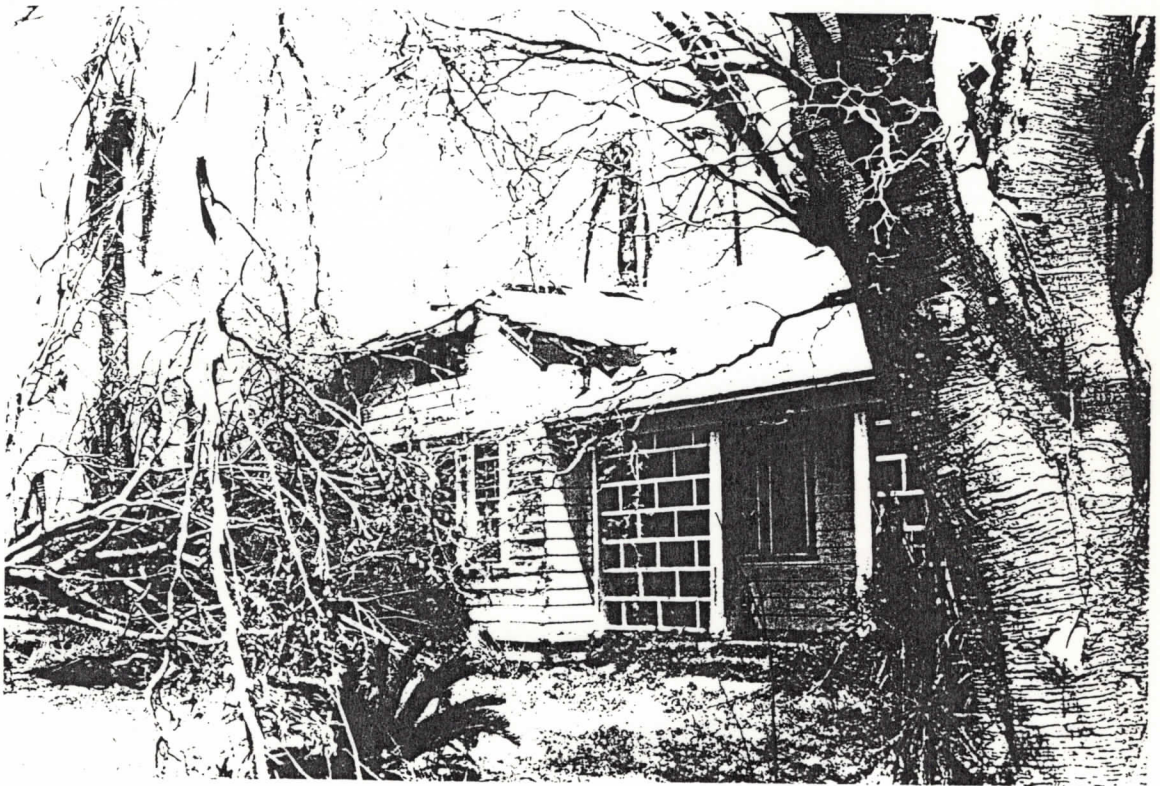
KROME

%	Comments
Exterior Walls	1	
Frame (General Condition)	0	
Frame Members	0	
Frame Connections	0	
Roof Framing	1	
Roof Covering	20	
Foundation	0	
Chimney(s)	0	
Doors	0	
Windows and Shutters	1	
Porch	0	
Downspouts and Gutters	NA	
Interior Bearing/Shear Walls	0	
Partitions (Nonbearing)	1	
Floor(s)	1	
Stair(s)	NA	
Glass	1	
Mechanical Equipment	NO	
Electrical Equipment	NO	
Garden and Trees	40	
Fences and Garden Walls	NA	
Walkways and Sidewalks	0	
Other: <u>Driveway(s)</u>	30	<u>Rock Damage</u>
Total Damage	15%

Recommendations for Immediate Stabilization ROOF IS CURRENTLY
LEAKING

Recommendations for Immediate Actions ROOF NEEDS TO BE REDONE

Recommendations for Future Repair Work CEDAR SHAKES WILL NEED TO
BE REMOVED BEFORE METAL TILE WILL BE ABLE
TO BE REPLACED; ^(Interior) CONCRETE WALLS WILL NEED
SOME TREATMENT
